Navajo Abandoned Uranium Mine

Site Screen Report

AEC Plot 3 AUM Site

August 2010

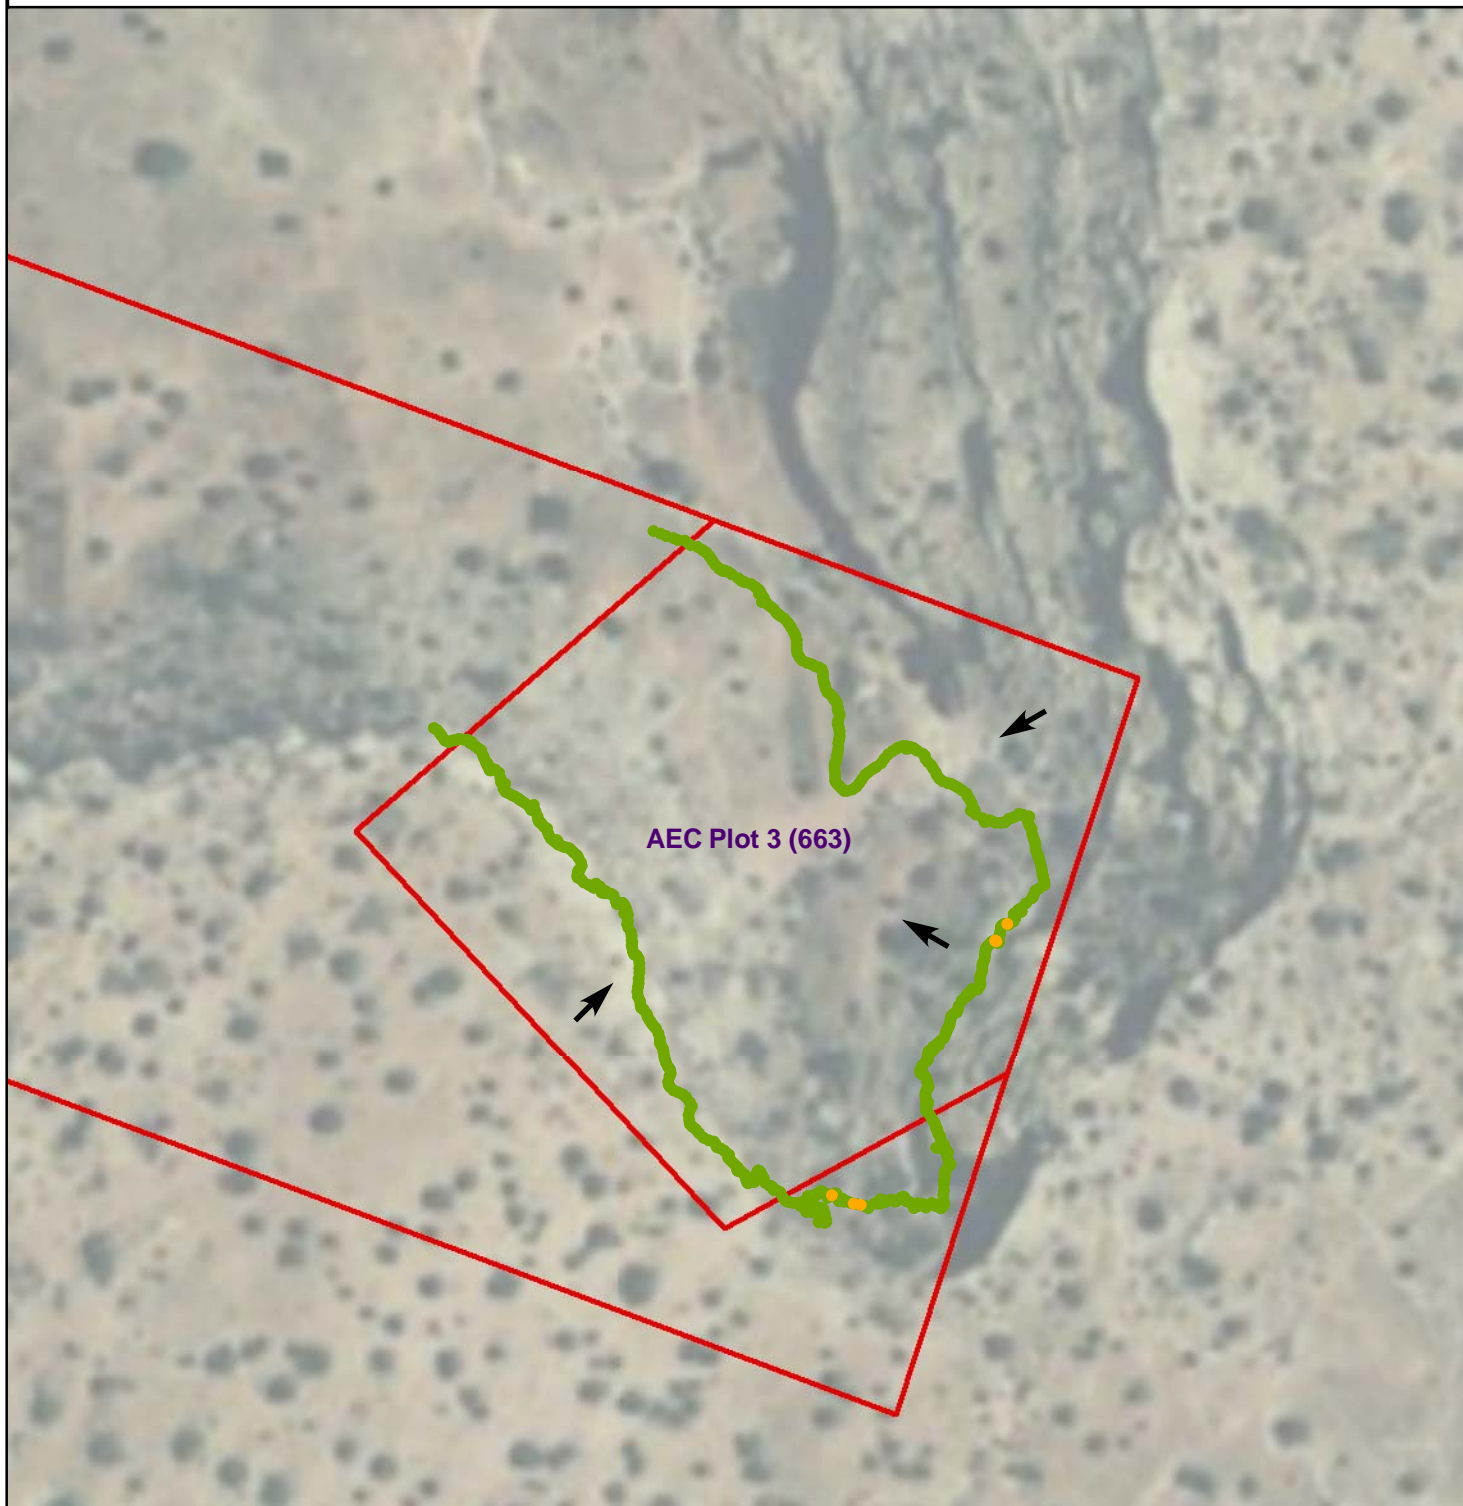
**Figure 1 - Gamma Radiation Measurements, Above Two Times Background
AEC Plot 3 (663)
Sweetwater Chapter, Navajo Nation**

Gamma survey conducted 06/2010
Measured as counts per minute (cpm)

Average background = 9,634 cpm

A total of 823 gamma radiation measurements were collected from the mine site, ranging from 9,103 cpm to 21,331 cpm. The measurements are represented in Figures 1 and 2.
